AFWAL-TR-83-4039

RAIN EROSION MECHANISMS OF  
FLUOROELASTOMER AND POLYURETHANE  
COATINGS ON SELECTED COMPOSITE  
SUBSTRATES

APRIL 1983

Special Interim Report for the Period July 1980 - February 1983

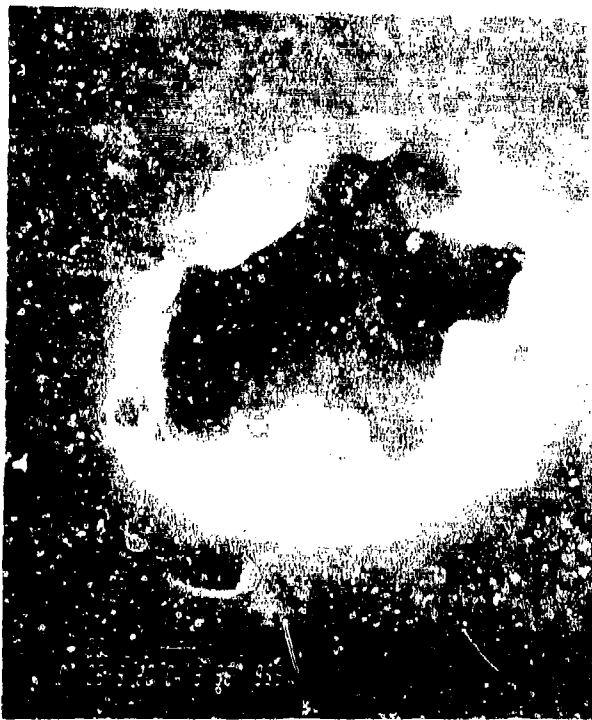
Figure 17. Fluoroelastomer Coated Graphite Epoxy Composite,  
90° Impact Angle.

Erosion damage was introduced into the fluoroelastomer coating during exposure to rainfield conditions at an impact angle of 90°. The surface damage after five and 10 minutes of rainfield exposure is shown in Figure 17. The erosion damage was characterized by local removal of coating materials, resulting in single crater formations in the 10 micron size range (Figure 17A) or agglomeration of such craters (Figure 17B). Furthermore, crater formation was associated with microcracks in the coating as revealed in Figure 17C. These microcracks were several microns in length and one to two microns in width.

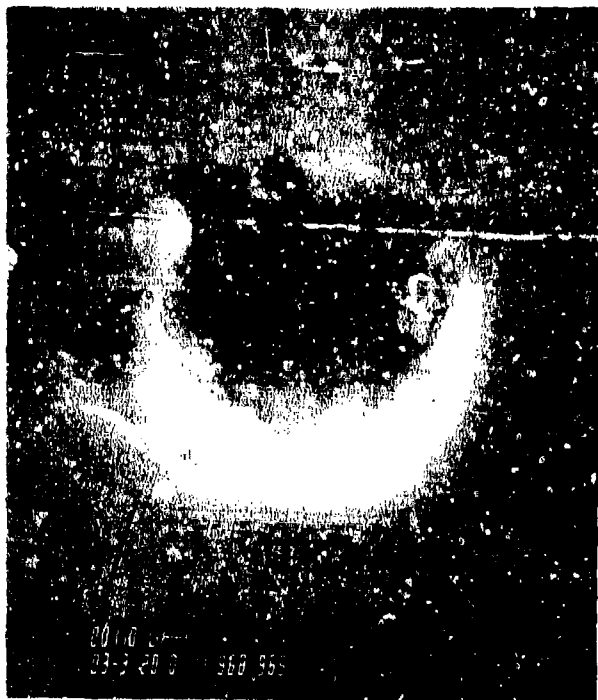
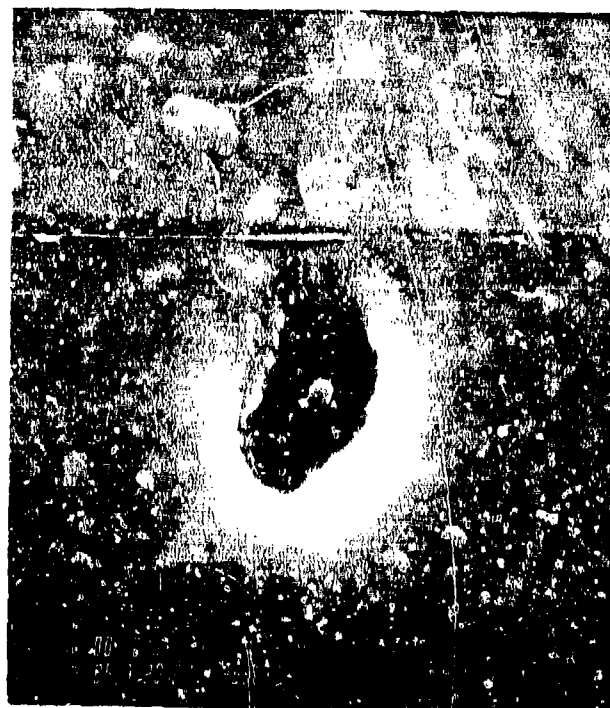
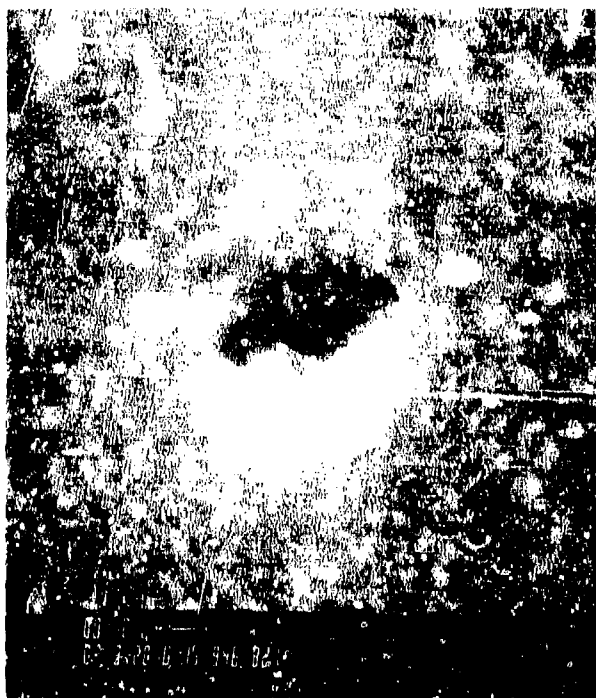
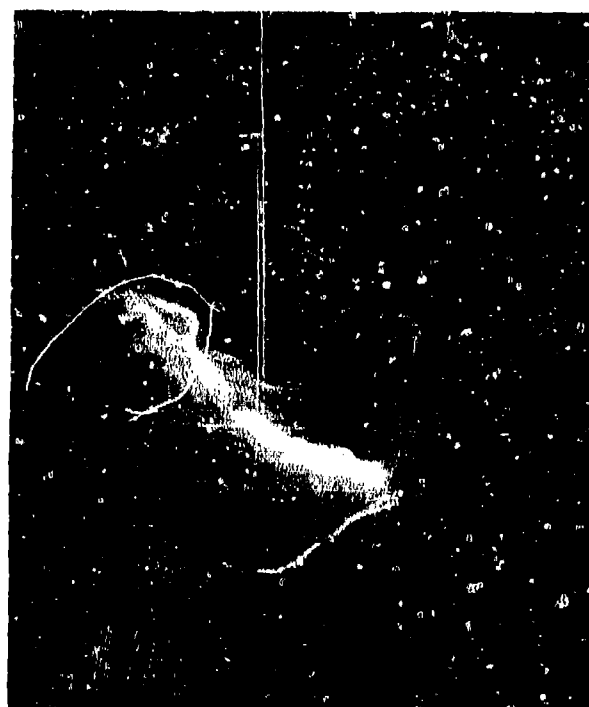
Figure 19. Fluorocelastomer Coated Quartz Polyimide Composite,  
90° Impact Angle.

exposure to rainfield conditions up to 30 minutes in duration. The damage illustrated was characterized by formation of localized erosion sites in the 10 micron size range after five minutes (Figure 19A and 19B) and 10 minutes (Figure 19C and 19D) of rainfield exposure. Rainfall exposure intervals of 15 minutes to 30 minutes resulted in the formation of clusters of single erosion sites as shown in Figure 20. Furthermore, the erosion damage after 30 minutes of rainfield exposure at a 90° impact angle resulted in coating cracking and delamination (Figure 21A) followed by severe erosion damage incurred in the quartz polyimide substrate (Figure 21B and 21C). Erosion damage in the quartz polyimide substrate material was characterized by broken quartz fibers (Figure 21B) as well as by polyimide resin removal (Figure 21C).

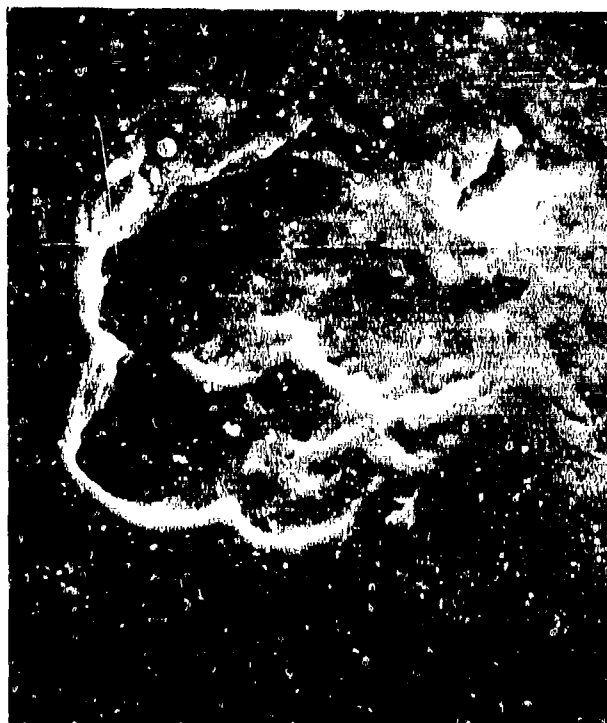
Figure 20. Fluoroclastomer Coated Quartz Polyimide Composite,  
90° Impact Angle.

Figures 19 and 20 exhibit the erosion damage at a 90° impact angle on the fluoroelastomer coating surface after:

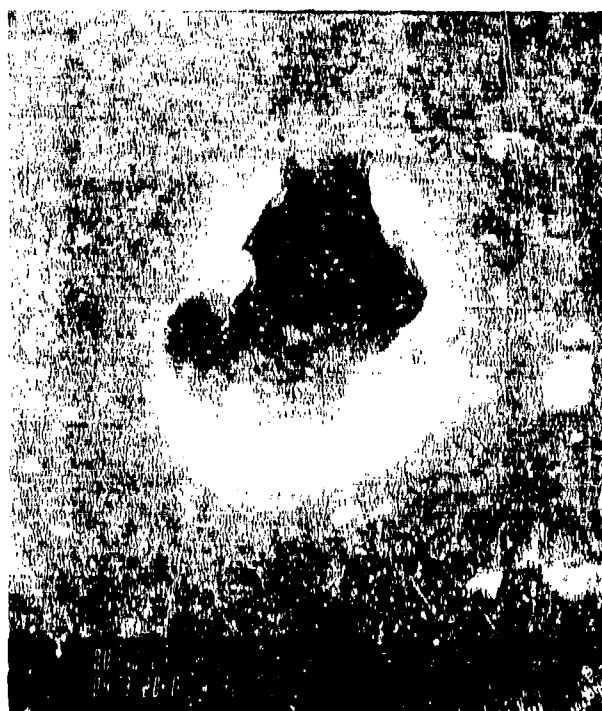
Figure 23. Fluoroelastomer Coated Graphite Epoxy Composite,  
30° Impact Angle.

The graphite epoxy substrates coated with the fluoroelastomer coating and exposed to rainfield conditions at a 30° impact angle for time intervals of five minutes to 180 minutes duration resulted in surface erosion damage as shown in Figure 23. The mode of damage was characterized by local coating material removal followed by the formation of isolated craters several microns in size.

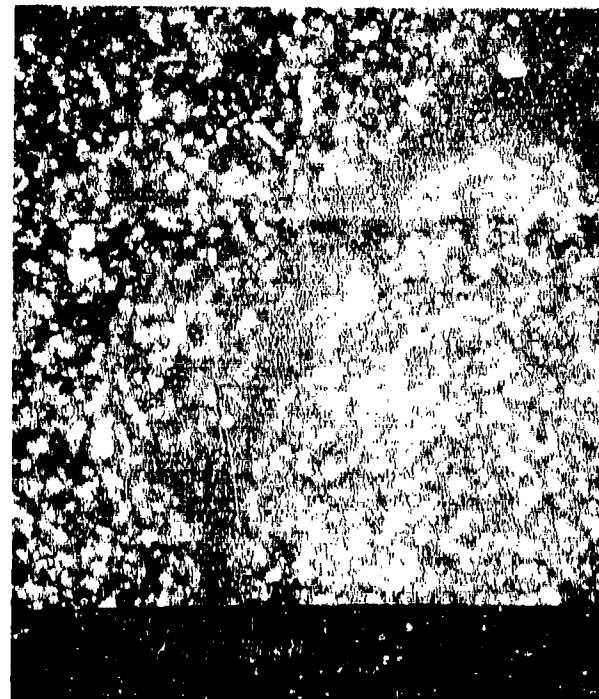
Figure 26. Polyurethane Coated Glass Epoxy Composite,  
90° Impact Angle.

Surface structure and morphology of the polyurethane coated glass epoxy composite substrates after exposure to rainfield conditions at a 90° impact angle for intervals of five minutes to 40 minutes are shown in Figure 26. The erosion damage was associated with localized material removal from the coating surface resulting in single craters or clusters of craters as shown in Figure 26C and 26E. The presence of the grain-type structures as well as the titanium dioxide pigments were not directly associated with local erosion processes as clearly shown in Figures 26A, 26D, and 26B, respectively.
